Landspout tornado Schuinesloot/Slagharen

17/4/2024

Schuinesloot and Slagharen, The Netherlands: On April 17th

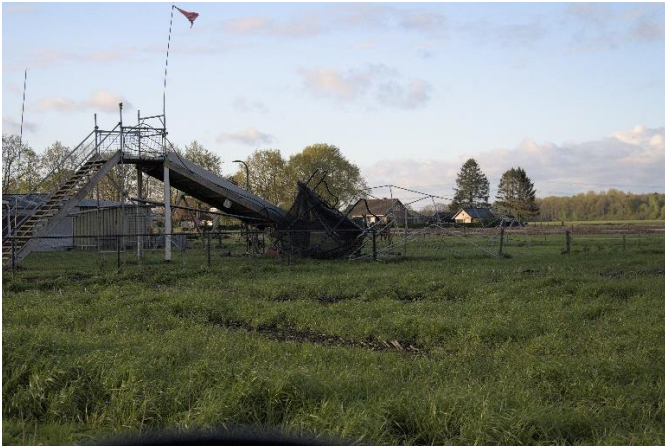
Near this location, a trampoline was overturned and a poorly built greenhouse was also overturned.

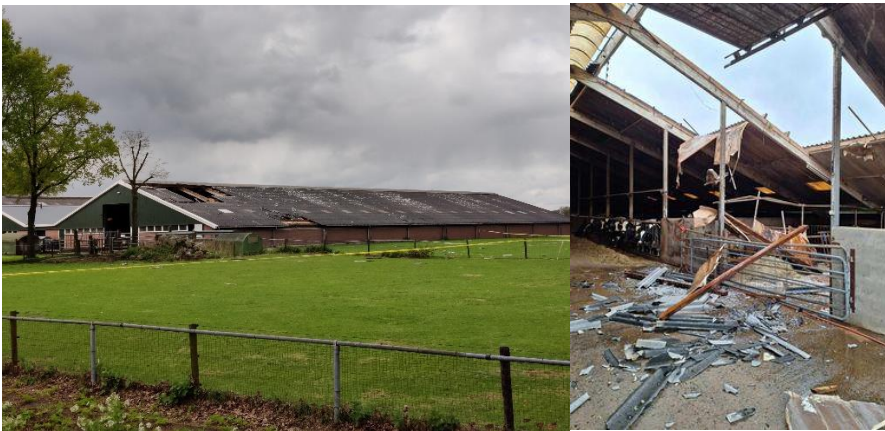
Roof damage was observed at a farm near the next location. The building was poorly built, the roof was made of asbestos sheets with isolation panels underneath. Video shows debris rotating, but not being picked up, something that did happen later on. The vortex was clearly visible because of dust and sand.

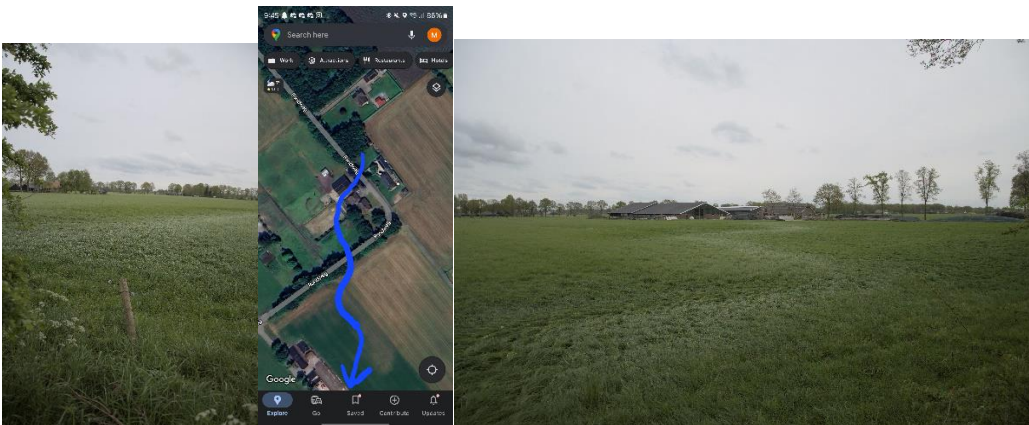
Small branches littered the field near the impacted structure and were debarked. At 3:24:58PM (Local time), security footage shows a vortex moving through the grass and right past a home. This video also shows small debris flying through the sky across the street. A neighboring home shows a singular roof tile missing. This is a well-built structure. Near this location, a path is observed in a field. A fence post was angled over 45 degrees and a 4.5cm branch torn off a tree. This post was potentially impacted by one of the pipes described in the following section.

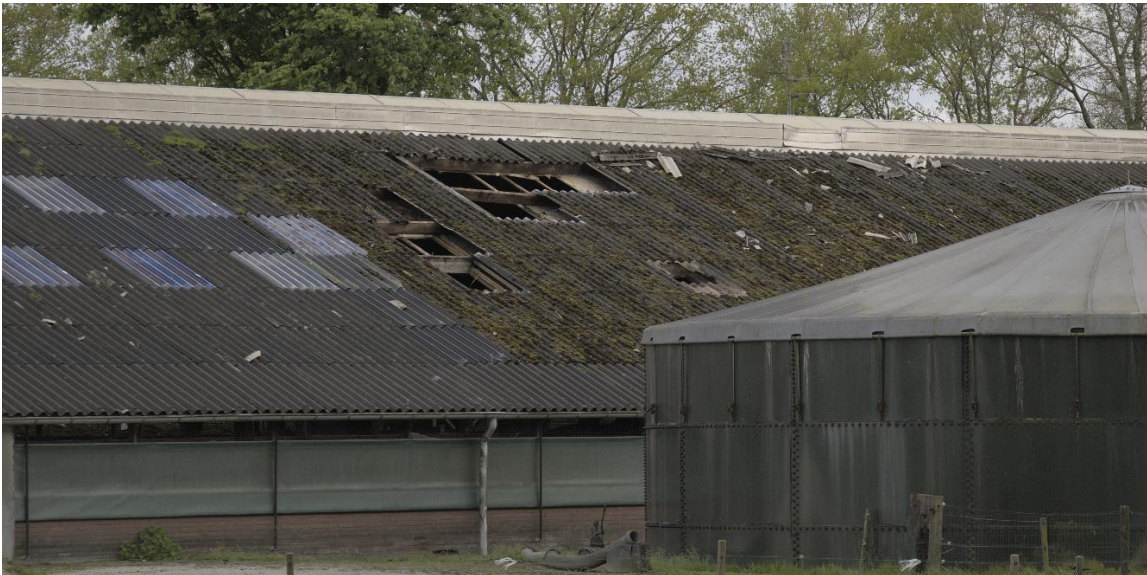
The next series of structures impacted consisted of three barns and a house, located on the same property. As the circulation crossed the road, it took out a tarp, but left two more tarps in place. It then hit the first barn, where there's damage to the poorly built, asbestos roof.

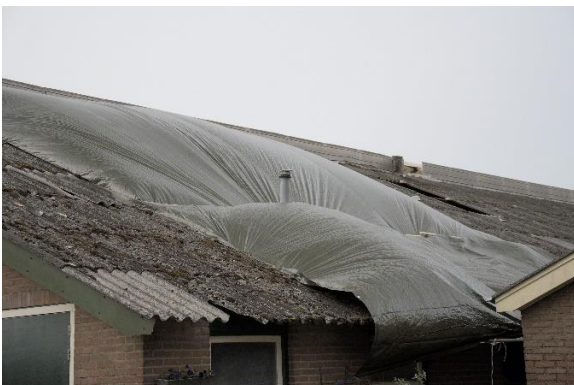
The other side of this barn shows worse damage, though was covered by a tarp after the impact. We believe we found fragments of the clear sections approximately 1070 meters away.

This debris was lifted and carried some distance, suggesting that between this and the last barn, the landspout may have changed into a regular tornado. This then suggests that this may have been a hybrid tornado.

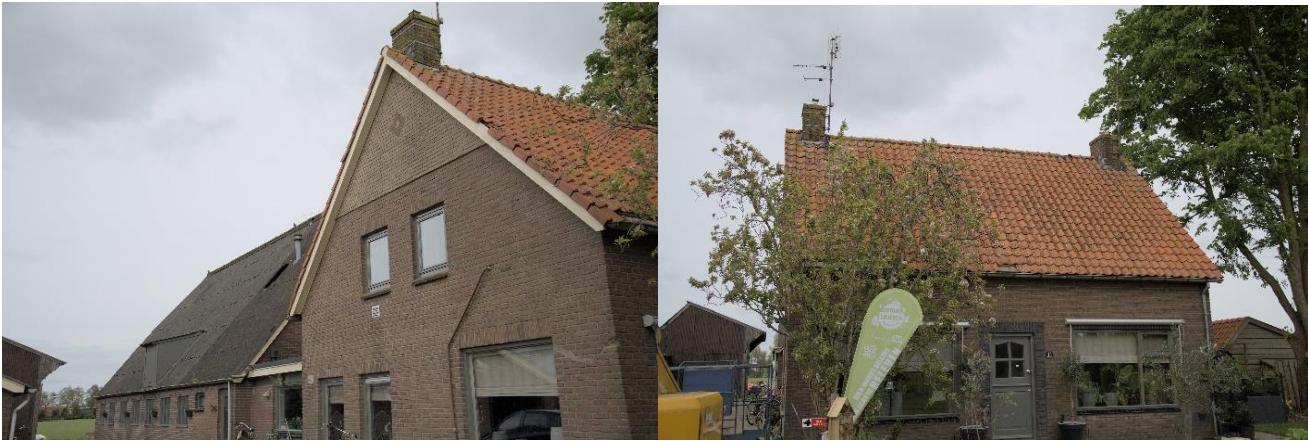
The house on that property was impacted next, it was a well-built home with minor roof damage

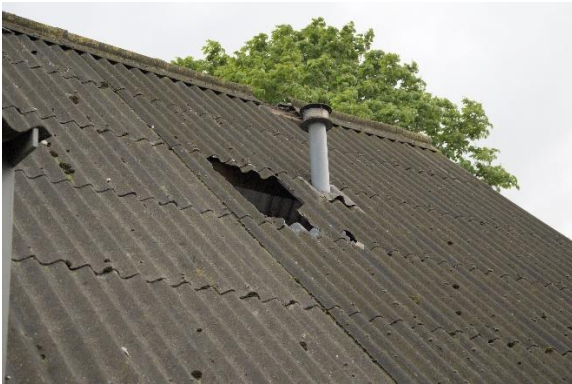
The barn next to the house shows minimal roof damage (likely due to debris impacting the structure) and some lead under the chimney was slightly pulled upwards:

There are several holes present in the poorly built roof. Only small fragments are left on the outside, which motivated the belief of the damage to this particular structure to be impacts, rather than direct wind.

The lead being pulled upward appears to be the result of the chimney shifting after debris impacting it or winds pushing it over, with the first being the most likely case.

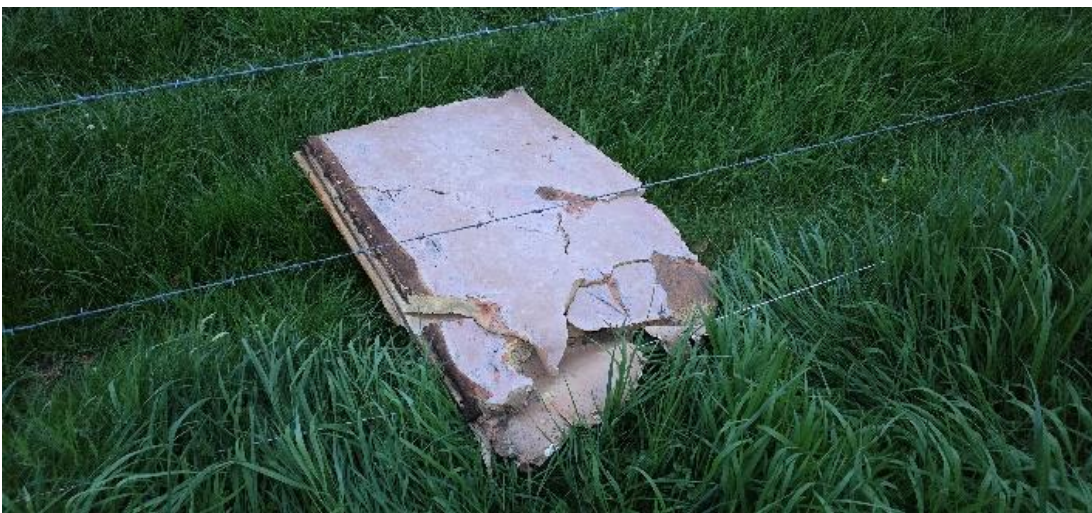
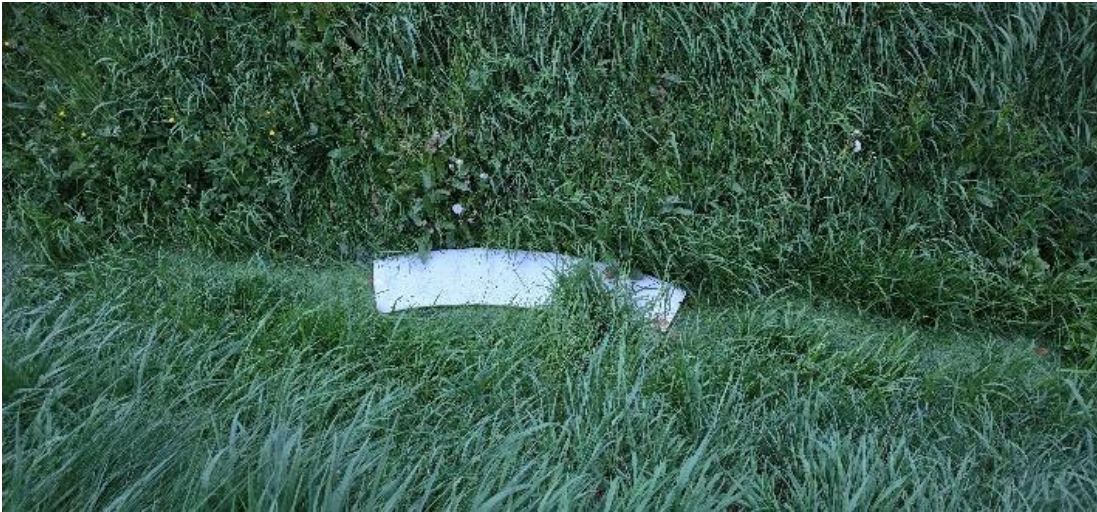
Entering the very east side of Slagharen, we found debris in the form of an isolation panel, plastic flower pot and an unknown piece in a ditch. The isolation has possibly been carried for 1.7km.

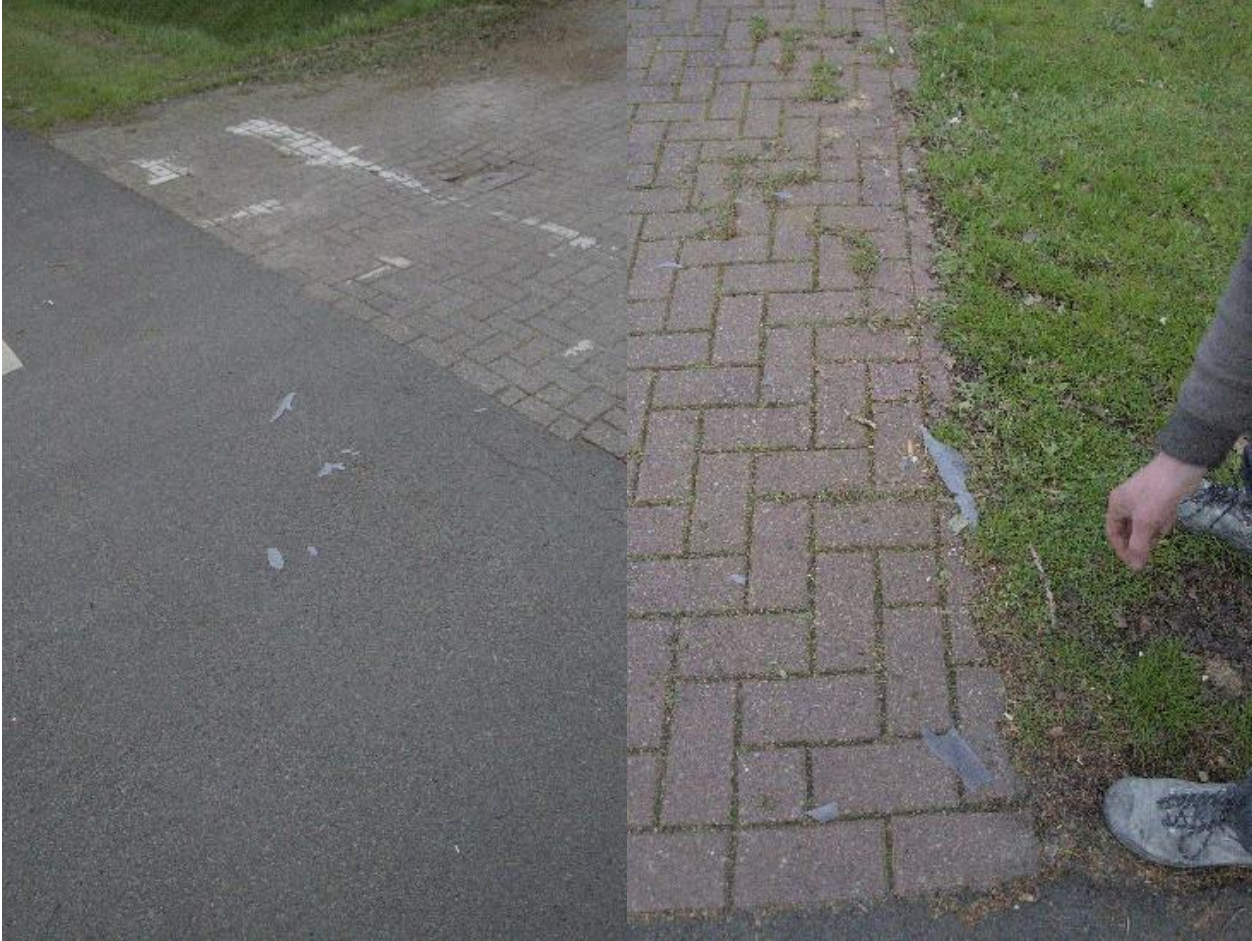
The circulation looked to have stayed over open fields as there was no damage found in the neighborhood. This would indicate a left turn, right before entering town. This behavior is common for tornadoes, formed from a supercell, but we've never heard of a landspout behaving like this. We found some small debris, potentially from the barn mentioned earlier.

The debris match the clear panels on the barn 1070 meters back. Only small fragments were present at the location, but were easily identified by the shape and color.

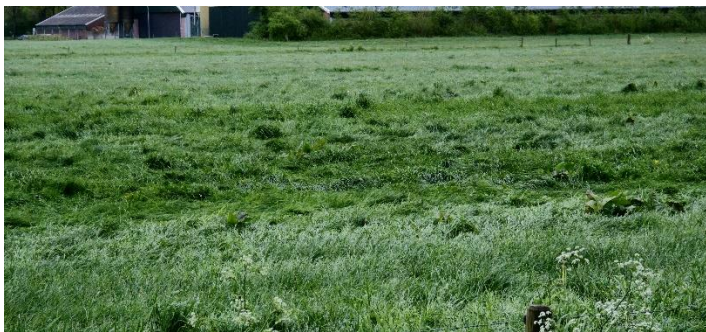
Patterns in grass, indication of circulation? Between the last farm to be hit and the amusement park:

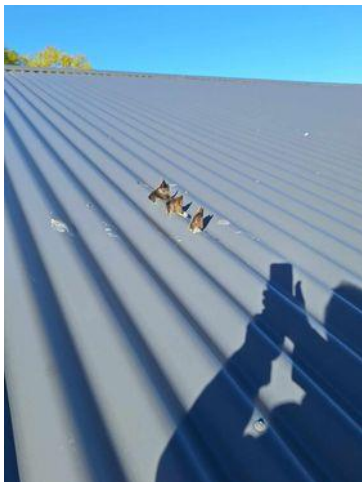
Debris lodged into a roof near the first barn to be impacted:
